Refurbishment Survey

Flat 6
14 Somerset Road
London
W13 9PB
UPRN: 0301460SOM

Evolution Environmental
Barham Court
Maidstone
Kent
ME18 5BZ

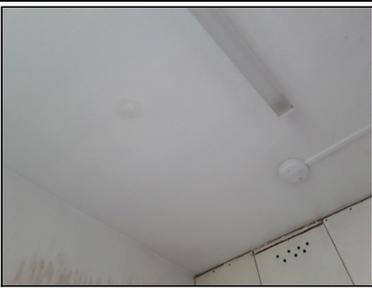
Survey Date:	Lead Surveyor	Survey Type	Floor	Analysis
	14 Dec 2021	[REDACTED]	Refurbishment Survey	Ground Floor	Chrysotile (1)
	Building	Room	Item	Quantity	
	14 Somerset Road - Flat 6	Kitchen G01	Textured Coating Ceiling	12m ²	
	Sample No (S,SP,P,As)	Product Type	Surface Treatment	Condition	Accessibility
	AG006683 (S)	Textured Coating (1)	Surface Sealed (1)	Low Damage (1)	Occasionally likely to be disturbed
	Material Risk Score				
4					
Recommended action	A - Remove				
Surveyor comments	N/A

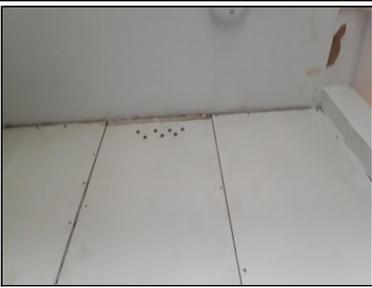
Survey Date:	Lead Surveyor	Survey Type	Floor	Analysis
	14 Dec 2021	[REDACTED]	Refurbishment Survey	Ground Floor	N/A
	Building	Room	Item	Quantity	
	14 Somerset Road - Flat 6	Kitchen G01	No Access within Boxing as it will cause excessive damage	N/A	
	Sample No (S,SP,P,As)	Product Type	Surface Treatment	Condition	Accessibility
	Visual	N/A	N/A	N/A	N/A
	Material Risk Score				
N/A					
Recommended action	Inspection Required				
Surveyor comments	N/A

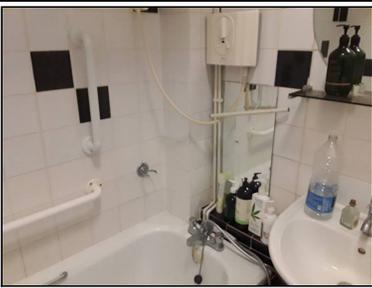
Survey Date:	Lead Surveyor	Survey Type	Floor	Analysis
	14 Dec 2021	[REDACTED]	Refurbishment Survey	Ground Floor	N/A
	Building	Room	Item	Quantity	
	14 Somerset Road - Flat 6	Bathroom/WC G02	No Access within Boxing as it will cause excessive damage	N/A	
	Sample No (S,SP,P,As)	Product Type	Surface Treatment	Condition	Accessibility
	Visual	N/A	N/A	N/A	N/A
	Material Risk Score				
	N/A				
Recommended action	Inspection Required				
Surveyor comments	N/A

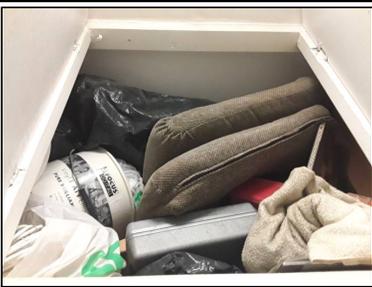
Survey Date:	Lead Surveyor	Survey Type	Floor	Analysis
	14 Dec 2021	[REDACTED]	Refurbishment Survey	Ground Floor	N/A
	Building	Room	Item	Quantity	
	14 Somerset Road - Flat 6	Bathroom/WC G02	Limited access within Cupboard due to storage	N/A	
	Sample No (S,SP,P,As)	Product Type	Surface Treatment	Condition	Accessibility
	Visual	N/A	N/A	N/A	N/A
	Material Risk Score				
	N/A				
Recommended action	Inspection Required				
Surveyor comments	N/A
