R B ASBESTOS CONSULTANTS

ASBESTOS MANAGEMENT PLAN & REGISTER ANNUAL INSPECTION

TJ HUGHES, 177/178 TERMINUS ROAD, EASTBOURNE, BN21 3NX

INSPECTION DATE: 22 JANUARY 2019

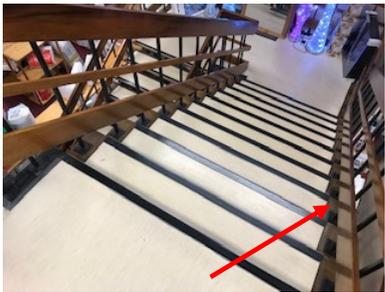
Location:	Main Staircase (all floors)				Original Survey N ^o :	1683	Original Survey Date:	3 May 2007	
	Description:	Stair noses				AMP Number:	R-12589			
	Sample Number:	SP 1683/001				Date Inspected:	22 January 2019			
	Quantity:	Full staircase				Next Inspection Date:	January 2020			
	Accessibility:	High				Surface Treatment:	Composite materials	Frequency of Use:	Daily	
	Risk Category	C – Low Risk	MRS:	2	PRS:	12	Condition:	Good	Asbestos Type:	SP Chrysotile
	Comments/Actions: Item not labelled. Any remedial or removal works to be undertaken by a trained contractor under CAR 2012

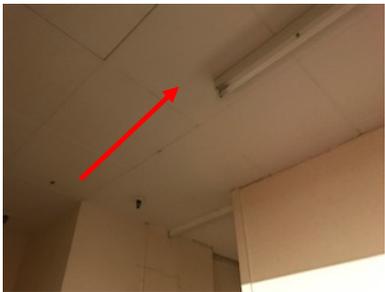
Location:	Third Floor - Admin Areas & Stairwell Foyer				Original Survey N ^o :	0818	Original Survey Date:	26 February 2004	
	Description:	Asbestos insulating board AIB (ceiling tiles)				AMP Number:	R-12589			
	Sample Number:	RB0302				Date Inspected:	22 January 2019			
	Quantity:	Approx. 200 m²				Next Inspection Date:	January 2020			
	Accessibility:	Low				Original Survey N ^o :	Sealed	Frequency of Use:	Daily	
	Risk Category	C – Low Risk	MRS:	5	PRS:	13	Condition:	Good	Asbestos Type:	Amosite
	Comments/Actions: Item labelled. Any remedial or removal works to be undertaken by a licensed contractor under CAR 2012

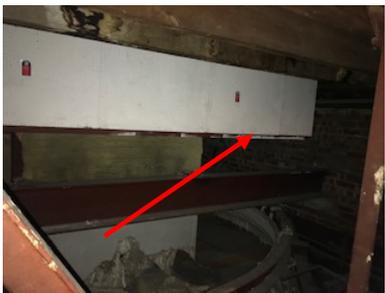
Location:	Third Floor Ceiling/Roof Void- Roof Space over Male Toilet				Original Survey N°:	0818	Original Survey Date:	26 February 2004	
	Description:	Asbestos insulation board (AIB) cladding between metal sheet as a boarding product				AMP Number:	R-12589			
	Sample Number:	RB0305				Date Inspected:	22 January 2019			
	Quantity:	Walls to Lift Motor Room (all walls)				Next Inspection Date:	January 2020			
	Accessibility:	Low				Surface Treatment:	Sealed	Frequency of Use:	Monthly	
	Risk Category	C – Low Risk	MRS	5	PRS	9	Condition:	Low	Asbestos Type:	Amosite
	Comments/Actions:	Manage. Any remedial or removal works to be undertaken by a licensed contractor under CAR 2012

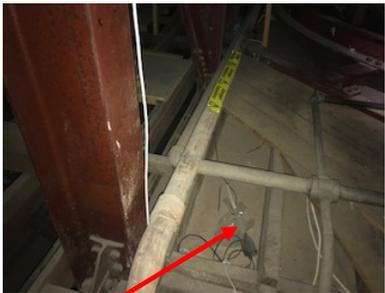
Location:	Third Floor Ceiling/Roof Void- Roof Space over Male Toilet				Original Survey N°:	0818	Original Survey Date:	26 February 2004	
	Description:	Asbestos insulation residue				AMP Number:	R-12589			
	Sample Number:	RB0306				Date Inspected:	22 January 2019			
	Quantity:	Various small amounts				Next Inspection Date:	January 2020			
	Accessibility:	Low				Surface Treatment:	Unsealed	Frequency of Use:	Infrequent	
	Risk Category	B – Medium Risk	MRS	12	PRS	14	Condition:	High damage	Asbestos Type:	Chrysotile
	Comments/Actions:	Material is present in small amounts around area of pipe area should undergo decontamination. No access without appropriate PPE Item labelled. Any remedial or removal works to be undertaken by a licensed contractor under CAR 2012

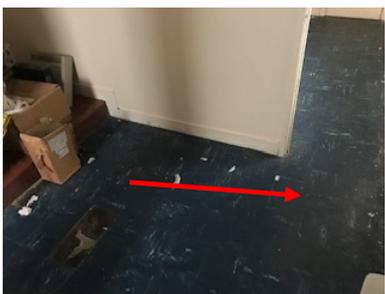
Location:	Third Floor – (Old) Ladies Toilet Stores				Original Survey N°:	0818	Original Survey Date:	26 February 2004	
	Description:	Thermoplastic floor tiles				AMP Number:	R-12589			
	Sample Number:	RB0307				Date Inspected:	22 January 2019			
	Quantity:	Approx. 30 m ²				Next Inspection Date:	January 2020			
	Accessibility:	Low				Surface Treatment:	Composite materials	Frequency of Use:	Weekly	
	Risk Category	D – Very Low Risk	MRS	2	PRS	6	Condition:	Good	Asbestos Type:	Chrysotile
	Comments/Actions:	Any remedial or removal works to be undertaken by a trained contractor under CAR 2012 Item labelled. Small repair required to damaged area <1 m²

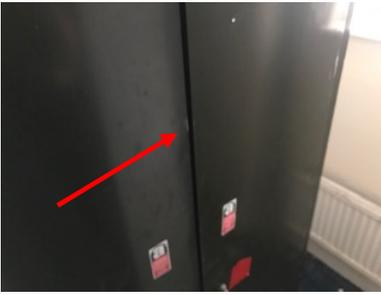
Location:	Third Floor – (Old) Ladies Toilet Stores				Original Survey N°:	0818	Original Survey Date:	26 February 2004	
	Description:	Asbestos insulation board (AIB) to doors and walls to fireproof cabinet				AMP Number:	R-12589			
	Sample Number:	SP RB0307A				Date Inspected:	22 January 2019			
	Quantity:	As seen				Next Inspection Date:	January 2020			
	Accessibility:	Medium				Surface Treatment:	Covered	Frequency of Use:	Monthly	
	Risk Category	B – Medium Risk	MRS	7	PRS	15	Condition:	Low	Asbestos Type:	SP Crocidolite
	Comments/Actions: Item labelled. Strongly presumed present as material visible on internal face of doors. Keep doors closed. Any remedial or removal works to be undertaken by a licensed contractor under CAR 2012

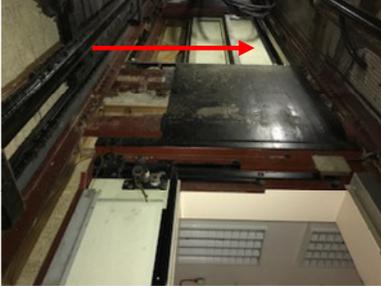
Location:	Second Floor - Lift (Basement to Second Floor)				Original Survey N°:	11354	Original Survey Date:	17 January 2018	
	Description:	Asbestos insulation board AIB Panels to lift doors				AMP Number:	R-12589			
	Sample Number:	11355/003				Date Inspected:	22 January 2019			
	Quantity:	X 8 doors				Next Inspection Date:	January 2020			
	Accessibility:	High				Surface Treatment:	Painted	Frequency of Use:	Daily	
	Risk Category	C Low Risk	MRS	6	PRS	9	Condition:	Historic Low damage	Asbestos Type:	Amosite
	Comments/Actions: Item not labelled. Manage or Remove. Any remedial or removal works to be undertaken by a licensed contractor under CAR 2012

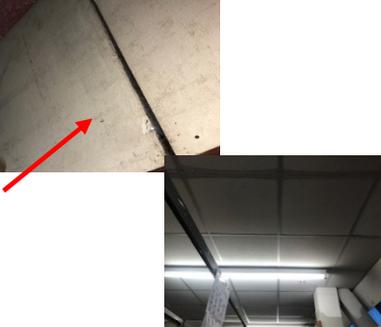
Location:	Second Floor Ceiling Void - Long Stock Room off Main Stock Room				Original Survey N°:	0818	Original Survey Date:	26 February 2004	
	Description:	Asbestos insulating board (AIB) above windows as seen (unsealed)				AMP Number:	R-12589			
	Sample Number:	RB0308				Date Inspected:	22 January 2019			
	Quantity:	Approx. 100 m ²				Next Inspection Date:	January 2020			
	Accessibility:	Low				Surface Treatment:	Unsealed	Frequency of Use:	Daily	
	Risk Category	C Low Risk	MRS	7	PRS	13	Condition:	Medium damage	Asbestos Type:	Amosite
	Comments/Actions: Item labelled. Now covered by false ceiling. Any remedial or removal works to be undertaken by a licensed contractor under CAR 2012

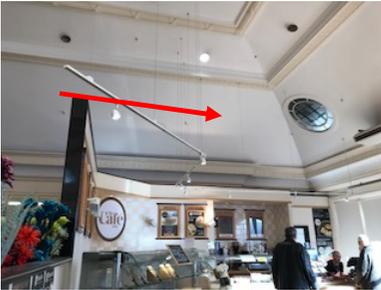
Location:	Second Floor				Original Survey N°:	0818	Original Survey Date:	26 February 2004	
	Description:	To main food serving areas				AMP Number:	R-12589			
	Sample Number:	LA1				Date Inspected:	22 January 2019			
	Quantity:					Next Inspection Date:	January 2020			
	Accessibility:	Limited access				Surface Treatment:		Frequency of Use:		
	Risk Category		MRS		PRS		Condition:		Asbestos Type:	
	Comments/Actions:									
	Proceed with caution may contain asbestos

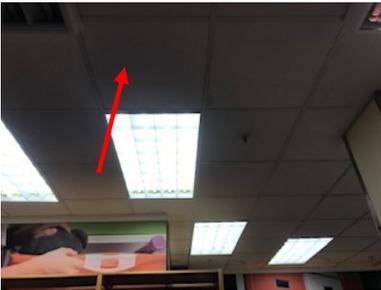
Location:	First Floor - Children's Clothes Area				Original Survey N°:	0818	Original Survey Date:	26 February 2004	
	Description:	Asbestos insulating board (AIB) in ceiling space				AMP Number:	R-12589			
	Sample Number:	RB0309				Date Inspected:	22 January 2019			
	Quantity:	Boarding in ceiling space				Next Inspection Date:	January 2020			
	Accessibility:	Low				Surface Treatment:	Unsealed	Frequency of Use:	Monthly	
	Risk Category	C – Low Risk	MRS	8	PRS	12	Condition:	Low damage	Asbestos Type:	Amosite
	Comments/Actions:									
	Was not safe to sample material near customers. Assume as asbestos until further investigation is possible. Risk score assumes tiles remain in situ Any remedial or removal works to be undertaken by a licensed contractor under CAR 2012 No access during this visit due to customers present.

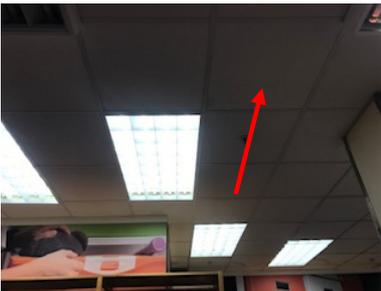
Location:	First Floor (See plan)				Original Survey N°:	0818	Original Survey Date:	26 February 2004	
	Description:	Asbestos insulating board (AIB) residue				AMP Number:	R-12589			
	Sample Number:	RB0310				Date Inspected:	22 January 2019			
	Quantity:	Unknown				Next Inspection Date:	January 2020			
	Accessibility:	Low				Surface Treatment:	Unsealed	Frequency of Use:	Monthly	
	Risk Category	B – Medium Risk	MRS	10	PRS	14	Condition:	High damage	Asbestos Type:	Amosite
	Comments/Actions:									
	Material is present in false ceiling near children's clothes. Full extent is unknown as sample point above Any remedial or removal works to be undertaken by a licensed contractor under CAR 2012 No access during this visit due to customers present.

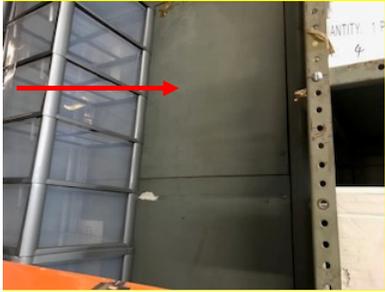
Location:	Ground Floor – to room off loading bay				Original Survey N°:	0818	Original Survey Date:	26 February 2004		
	Description:	Electrical unit (behind boxes)				AMP Number:	R-12589				
	Sample Number:	NA8				Date Inspected:	22 January 2019				
	Quantity:					Next Inspection Date:	January 2020				
	Accessibility:	No access				Surface Treatment:			Frequency of Use:		
	Risk Category		MRS		PRS		Condition:			Asbestos Type:	
	Comments/Actions:										
	Proceed with caution may contain asbestos

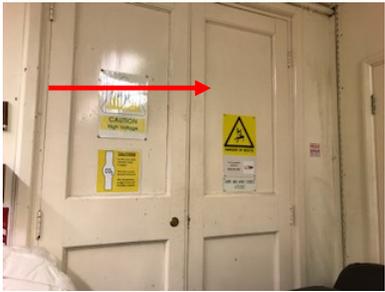
Location:	Basement				Original Survey N°:	0818	Original Survey Date:	26 February 2004		
	Description:	Sub station				AMP Number:	R-12589				
	Sample Number:	NA9				Date Inspected:	22 January 2019				
	Quantity:					Next Inspection Date:	January 2020				
	Accessibility:	No access – no keys on site				Surface Treatment:			Frequency of Use:		
	Risk Category		MRS		PRS		Condition:			Asbestos Type:	
	Comments/Actions:										
	Proceed with caution may contain asbestos

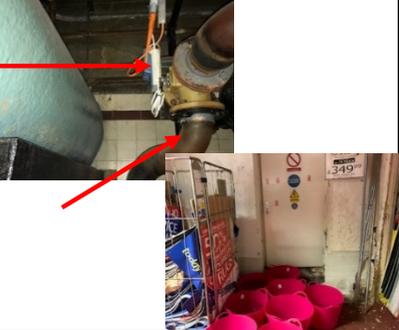
Location:	Basement - Boiler Room & adjacent Ventilation Machinery Room				Original Survey N°:	0818	Original Survey Date:	26 February 2004	
	Description:	Asbestos lagging residue				AMP Number:	R-12589			
	Sample Number:	RB0311				Date Inspected:	22 January 2019			
	Quantity:	48 m ² and 36 m ²				Next Inspection Date:	January 2020			
	Accessibility:	Low				Surface Treatment:	Unsealed	Frequency of Use:	6 Monthly	
	Risk Category	B – Medium Risk	MRS	12	PRS	16	Condition:	High damage	Asbestos Type:	Chrysotile
	Comments/Actions:									
	Item labelled: Any remedial or removal works to be undertaken by a licensed contractor under CAR 2012. Not accessed this visit due to buckets catching water. No access without appropriate PPE

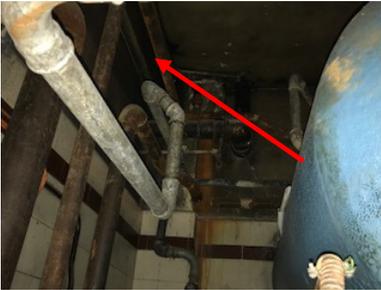
Location:	Basement Boiler Room rear of boiler				Original Survey N°:	26 February 2004	Original Survey Date:	26 February 2004	
	Description:	Asbestos cement flue				AMP Number:	R-12589			
	Sample Number:	RB0312				Date Inspected:	22 January 2019			
	Quantity:	Flue length unknown				Next Inspection Date:	January 2020			
	Accessibility:	Low				Surface Treatment:	Unsealed	Frequency of Use:	6 Monthly	
	Risk Category	B – Medium Risk	MRS	12	PRS	16	Condition:	High damage	Asbestos Type:	Chrysotile
	Comments/Actions: Any remedial or removal works to be undertaken by a licensed contractor under CAR 2012. Not accessed this visit due to buckets catching water. No access without appropriate PPE

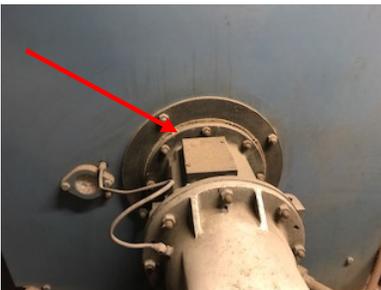
Location:	Basement Boiler Room				Original Survey N°:	11354	Original Survey Date:	17 January 2018	
	Description:	Gasket to boiler				AMP Number:	R-12589			
	Sample Number:	11354/001				Date Inspected:	22 January 2019			
	Quantity:	X 2				Next Inspection Date:	January 2020			
	Accessibility:	Low				Surface Treatment:	Covered	Frequency of Use:	6 Monthly	
	Risk Category	D – Very Low risk	MRS	4	PRS	8	Condition:	High damage	Asbestos Type:	Chrysotile
	Comments/Actions: Item not labelled. Any remedial or removal works to be undertaken by a trained contractor under CAR 2012 Not accessed this visit due to buckets catching water.

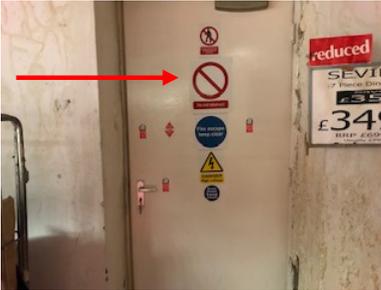
Location:	Basement Boiler Room				Original Survey N°:	11354	Original Survey Date:	17 January 2018	
	Description:	Panel to door				AMP Number:	R-12589			
	Sample Number:	SP 11354/002				Date Inspected:	22 January 2019			
	Quantity:	X 1				Next Inspection Date:	January 2020			
	Accessibility:	Low				Surface Treatment:	Covered	Frequency of Use:	6 Monthly	
	Risk Category	C – Low risk	MRS	5	PRS	9	Condition:	Good	Asbestos Type:	SP Crocidolite
	Comments/Actions: Item labelled. Any remedial or removal works to be undertaken by a trained contractor under CAR 2012

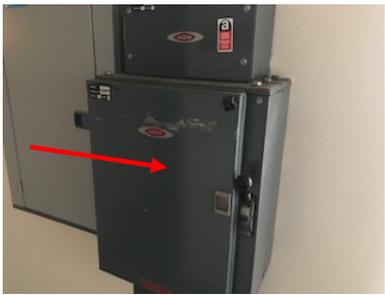
Location:	Throughout Building – Removed from Canteen				Original Survey N°:	2590	Original Survey Date:	8 June 2009		
	Description:	ACM's to fuse boxes				AMP Number:	R-12589				
	Sample Number:	RB02590/001				Date Inspected:	22 January 2019				
	Quantity:	Unknown				Next Inspection Date:	January 2020				
	Accessibility:	Inaccessible				Surface Treatment:	Covered	Frequency of Use:	6 Monthly		
	Risk Category	D – Very Low Risk	MRS	2	PRS	3	Condition:	Good	Asbestos Type:	Assumed Chrysotile	
Comments/Actions: Any remedial or removal works to be undertaken by a trained contractor under CAR 2012. Item labelled.

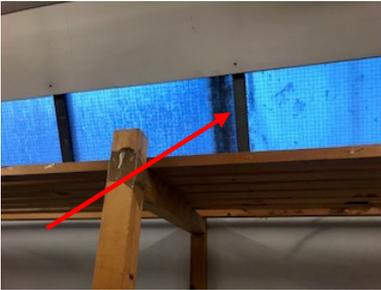
Location:	External roof				Original Survey N°:	9990	Original Survey Date:	26 January 2017	
	Description:	Gasket seals to roof windows				AMP Number:	R-12589			
	Sample Number:	SP 9990/001				Date Inspected:	22 January 2019			
	Quantity:	All				Next Inspection Date:	January 2020			
	Accessibility:	Low				Surface Treatment:	Covered	Frequency of Use:	Annually	
	Risk Category	D – Very Low	MRS	5	PRS	8	Condition:	Good	Asbestos Type:	SP Crocidolite
	Comments/Actions: Any remedial or removal works to be undertaken by a trained contractor under CAR 2012. Item not labelled.

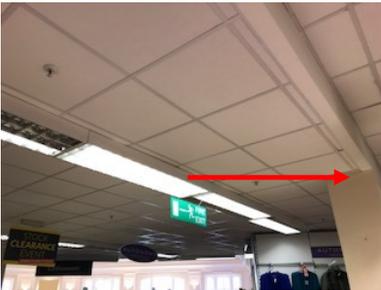
Location:	Throughout Building				Original Survey N°:	0818	Original Survey Date:	26 February 2004	
	Description:	To covered pillars and bulkheads				AMP Number:	R-12589			
	Sample Number:	NA2				Date Inspected:	22 January 2019			
	Quantity:					Next Inspection Date:	January 2020			
	Accessibility:	No access				Surface Treatment:		Frequency of Use:		
	Risk Category		MRS		PRS		Condition:		Asbestos Type:	
	Comments/Actions: Proceed with caution may contain asbestos

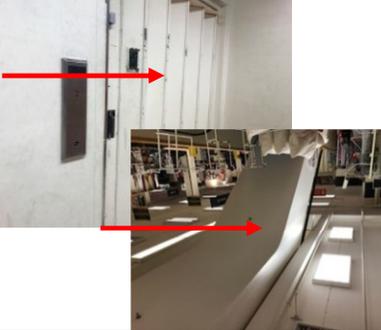
Location:	Throughout Building				Original Survey N°:	0818	Original Survey Date:	26 February 2004	
	Description:	To lift shaft & within escalator housing (internal aspects)				AMP Number:	R-12589			
	Sample Number:	NA3				Date Inspected:	22 January 2019			
	Quantity:					Next Inspection Date:	January 2020			
	Accessibility:	No access				Surface Treatment:		Frequency of Use:		
	Risk Category		MRS		PRS		Condition:		Asbestos Type:	
	Comments/Actions: Proceed with caution may contain asbestos

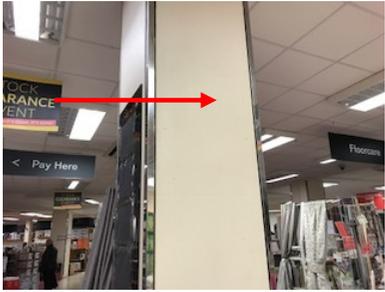
Location:	Throughout Building			Original Survey N°:	0818	Original Survey Date:	26 February 2004	
	Description:	Behind general fittings and claddings to walls and pillars			AMP Number:	R-12589			
	Sample Number:	NA4			Date Inspected:	22 January 2019			
	Quantity:				Next Inspection Date:	January 2020			
	Accessibility:	No access			Surface Treatment:		Frequency of Use:		
	Risk Category		MRS		PRS	Condition:		Asbestos Type:	
	Comments/Actions:								
	Proceed with caution may contain asbestos

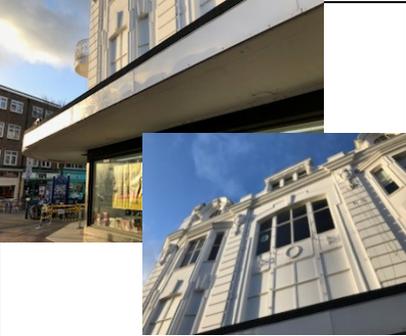
Location:	Throughout Building			Original Survey N°:	0818	Original Survey Date:	26 February 2004	
	Description:	Within ceiling voids and shop front canopy			AMP Number:	R-12589			
	Sample Number:	NA5			Date Inspected:	22 January 2019			
	Quantity:				Next Inspection Date:	January 2020			
	Accessibility:	Limited access			Surface Treatment:		Frequency of Use:		
	Risk Category		MRS		PRS	Condition:		Asbestos Type:	
	Comments/Actions:								
	Proceed with caution may contain asbestos

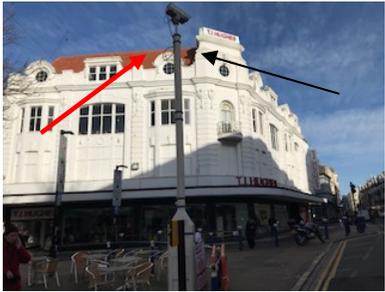
Location:	See below			Original Survey N°:	0818	Original Survey Date:	26 February 2004	
	Description:	To ceiling space directly over dome above restaurant. Ceiling space area to side was accessed near toilet area only			AMP Number:	R-12589			
	Sample Number:	NA6			Date Inspected:	22 January 2019			
	Quantity:				Next Inspection Date:	January 2020			
	Accessibility:	No access			Surface Treatment:		Frequency of Use:		
	Risk Category		MRS		PRS	Condition:		Asbestos Type:	
	Comments/Actions:								
	Proceed with caution may contain asbestos

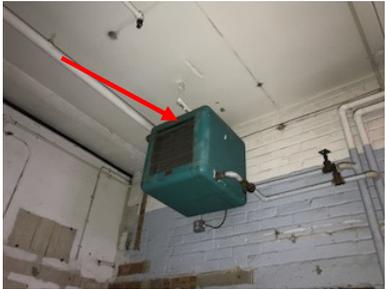
Location:	Throughout Store				Original Survey N°:	0818	Original Survey Date:	26 February 2004	
	Description:	Within high level heaters and fans (internal aspects)				AMP Number:	R-12589			
	Sample Number:	NA7				Date Inspected:	22 January 2019			
	Quantity:					Next Inspection Date:	January 2020			
	Accessibility:	No access				Surface Treatment:		Frequency of Use:		
	Risk Category		MRS		PRS		Condition:		Asbestos Type:	
	Comments/Actions:									
	Proceed with caution may contain asbestos

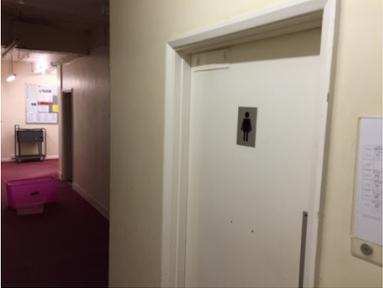
Location:	Third Floor - Offices			Original Survey N°:	0818	Original Survey Date:	26 February 2004		
	Description:	To ladies toilets			AMP Number:	11354				
	Sample Number:				Date Inspected:	17 January 2018				
	Quantity:				Next Inspection Date:	N/A				
	Accessibility:	No access – room now accessed NSM			Surface Treatment:		Frequency of Use:			
	Risk Category		MRS		PRS		Condition:		Asbestos Type:	
	Comments/Actions: Solid & plasterboard walls. Floor with modern vinyl floor tiles.

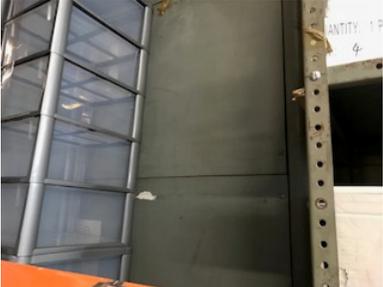
Location:	Ground Floor			Original Survey N°:	0818	Original Survey Date:	26 February 2004		
	Description:	To room off loading bay (locked)			AMP Number:	11354				
	Sample Number:	NA8			Date Inspected:	17 January 2018				
	Quantity:				Next Inspection Date:	N/A				
	Accessibility:	No access – room now accessed NSM			Surface Treatment:		Frequency of Use:			
	Risk Category		MRS		PRS		Condition:		Asbestos Type:

Comments/Actions: Solid ceiling & floor, solid & plasterboard walls, metal pipework

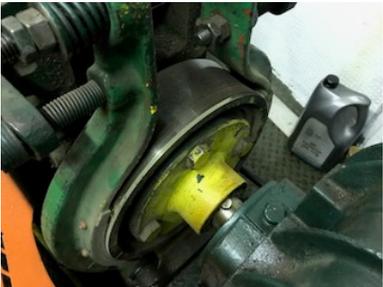
Location:	Lift Shaft			Original Survey N°:	11355	Original Survey Date:	17 January 2018		
	Description:	Brake lining			AMP Number:	11355				
	Sample Number:	11355/001			Date Inspected:	17 January 2018				
	Quantity:	X 1			Next Inspection Date:	N/A				
	Accessibility:	No access – shaft now accessed NSM			Surface Treatment:		Frequency of Use:			
	Risk Category		MRS		PRS		Condition:		Asbestos Type:	
	Comments/Actions: Accessed this visit. Solid ceiling, walls & floor. Timber structure to walls with mesh/cement.

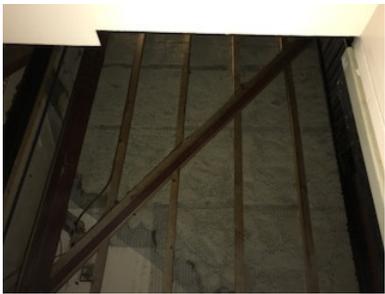
Location:	Lift Shaft				Original Survey N°:	11355	Original Survey Date:	17 January 2018	
	Description:	Wall cladding to lift shaft				AMP Number:	11355			
	Sample Number:	11355/002				Date Inspected:	17 January 2018			
	Quantity:					Next Inspection Date:	N/A			
	Accessibility:	No access – shaft now accessed NSM				Surface Treatment:		Frequency of Use:		
	Risk Category		MRS		PRS	Condition:		Asbestos Type:		
	Comments/Actions:									
	Accessed this visit. Solid ceiling, walls & floor.

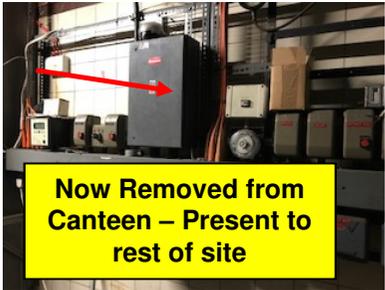
Location:	Removed from Canteen				Original Survey N°:	2590	Original Survey Date:	8 June 2009	
	Description:	ACM's to fuse boxes				AMP Number:	R-12589			
	Sample Number:	RB02590/001				Date Inspected:	22 January 2019			
	Quantity:	Unknown				Next Inspection Date:	January 2020			
	Accessibility:	Inaccessible				Surface Treatment:	Covered	Frequency of Use:	6 Monthly	
	Risk Category	D – Very Low Risk	MRS	2	PRS	3	Condition:	Good	Asbestos Type:	Assumed Chrysotile
	Comments/Actions:									
	REMOVED FROM CANTEEN
