REFURBISHMENT SURVEY (WITH MA + PA)

First floor, 54 Swanley Center, Swanley, Kent BR8 7TQ

9 Oct 2025

J003685

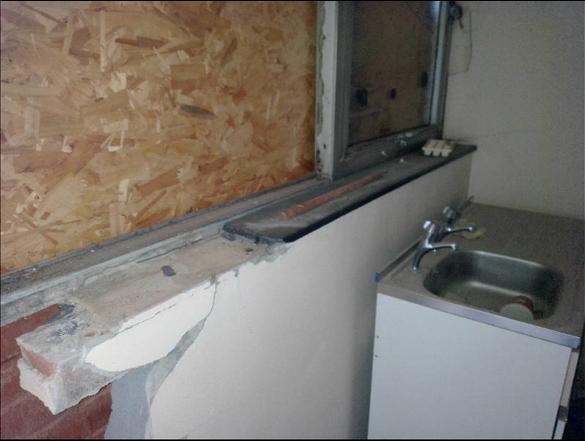
| Sample Location | | Sample Details | |
|---|---|---|---|
| Item Description | Eternite window sill | Item Comments | Damaged |
| Condition | Low Damage (1) | Frequency of maintenance | <1 per year |

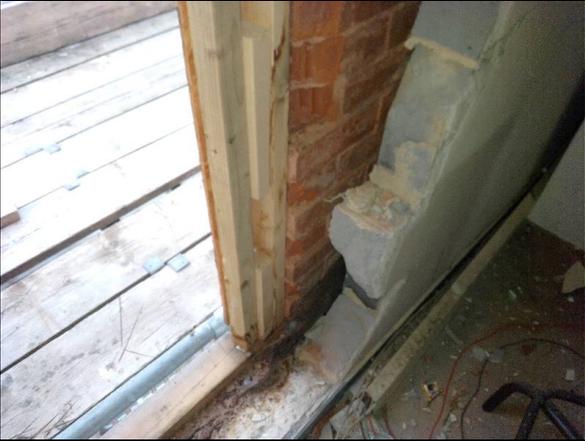
| Sample Location | | Sample Details | |
|---|---|---|---|
| Condition | N/A | Extent / Amt | 6lm |

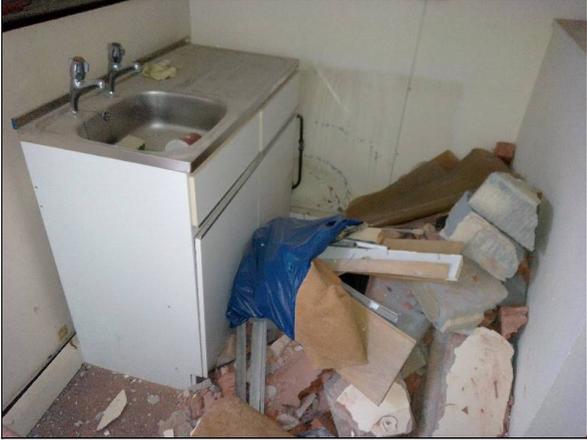
| Sample Location | | Sample Details | |
|---|---|---|---|
| Condition | Low Damage (1) | Frequency of maintenance | Unlikely |

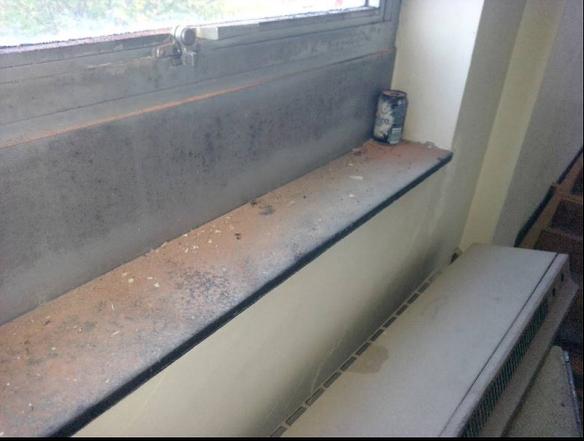
| Sample Location | | Sample Details | |
|---|---|---|---|
| Condition | Low Damage (1) | Frequency of maintenance | <1 per year |

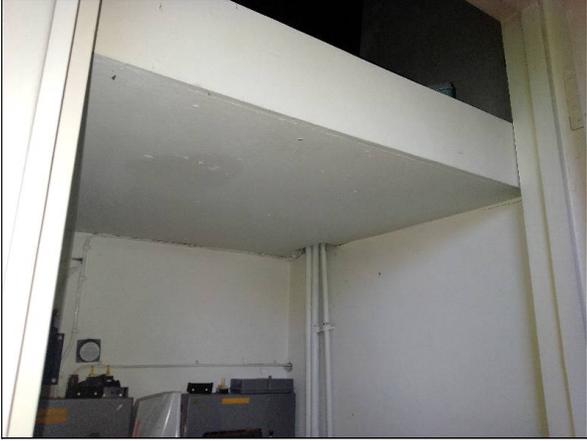
| Sample Location | | Sample Details | |
|---|---|---|--|
| Condition | Low Damage (1) | Frequency of maintenance | <1 per year |

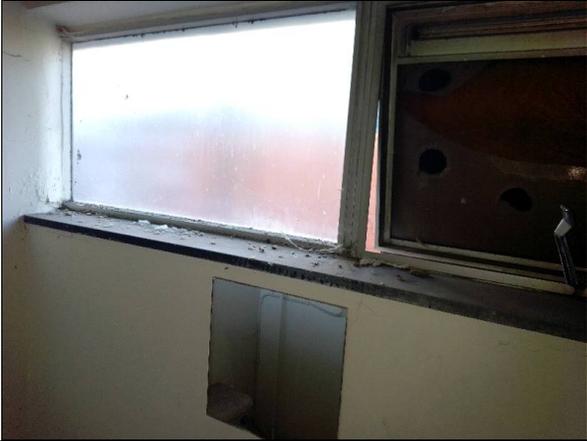
| Sample Location | | Sample Details | |
|---|---|---|---|
| Condition | Low Damage (1) | Frequency of maintenance | <1 per year |

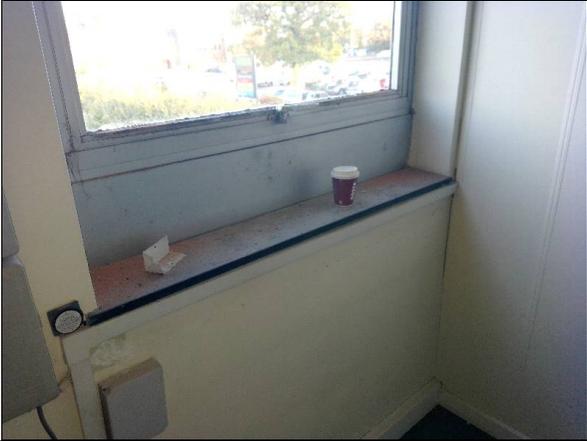
| Sample Location | | Sample Details | |
|---|---|---|---|
| Condition | Low Damage (1) | Frequency of maintenance | <1 per year |

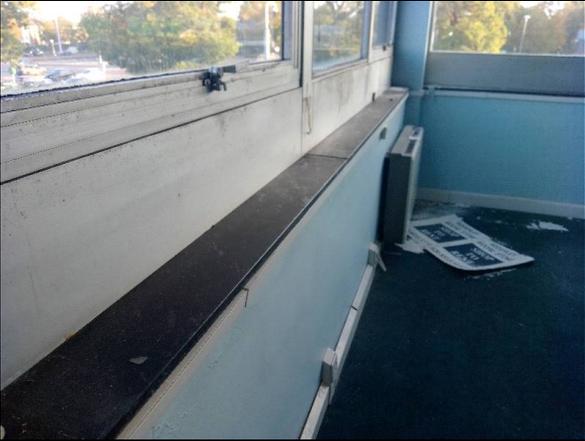
| Sample Location | | Sample Details | | |
|---|---|---|---|---|
| Condition | Low Damage (1) | Frequency of maintenance | <1 per year | |
